## **Preliminary Evaluation of Water Quality in the Vicinity of San Juan Generating Station and Recommended Corrective Actions**

PRELIMINARY INVESTIGATION INTO THE  
HYDROLOGIC CHARACTERISTICS  
OF THE  
WESTWATER AND SHUMWAY ARROYOS  
IN THE VICINITY OF THE  
SAN JUAN GENERATING STATION  
SAN JUAN COUNTY, NEW MEXICO

PREPARED BY  
METRIC CORPORATION  
LOS LUNAS, NEW MEXICO

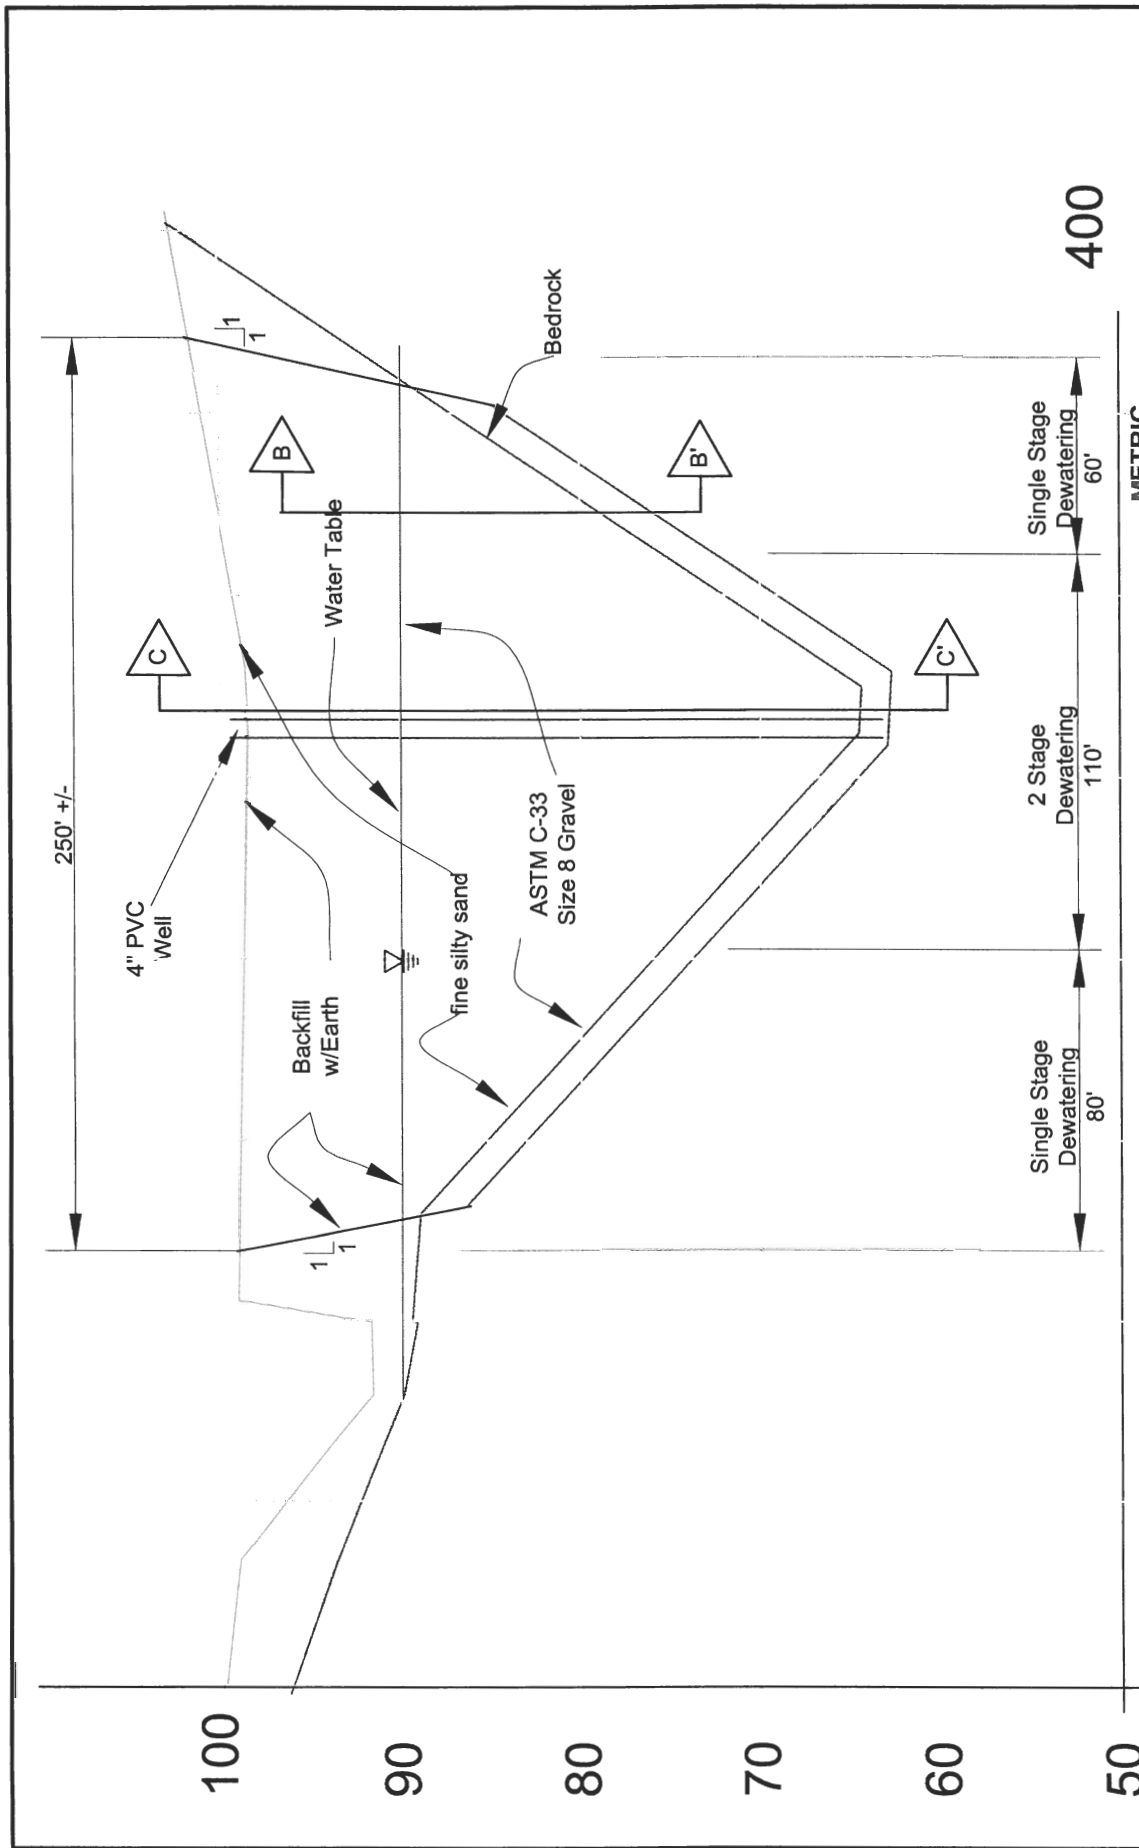
Figure 4

PROFILE  
LOCATION E TRENCH

The recommended corrective actions to address underground leakage at the San Juan Generating Station consist of the corrective actions listed in TABLE 4 including construction of a groundwater recovery trench at Location E which is about 4000 ft. down stream from the San Juan Generating Station along the groundwater flow path of the Qnt aquifer (FIGURE 2). The objective of the groundwater recovery trench would be to capture virtually all of the flow in the Qnt aquifer, including contributions from the San Juan Generating Station, and return the water to the process water system at the station for reuse. Location E was selected because it is downstream from the maximum distance that contaminants from San Juan Generating Station might have traveled in the Qnt aquifer based on a particle velocity of 90 ft/year and a travel time of 33 years. Additionally, it is in an undeveloped area and the Qnt aquifer is only about 250 ft. wide at that location. Also, it would not be necessary to disturb the arroyo channel to construct the recovery trench at Location E. Details of the proposed groundwater recovery trench construction are presented in FIGURE 4, 5 and 6. Preliminary estimates indicate that the total flow in the Qnt aquifer at Location E is about 16 ac.ft/yr.

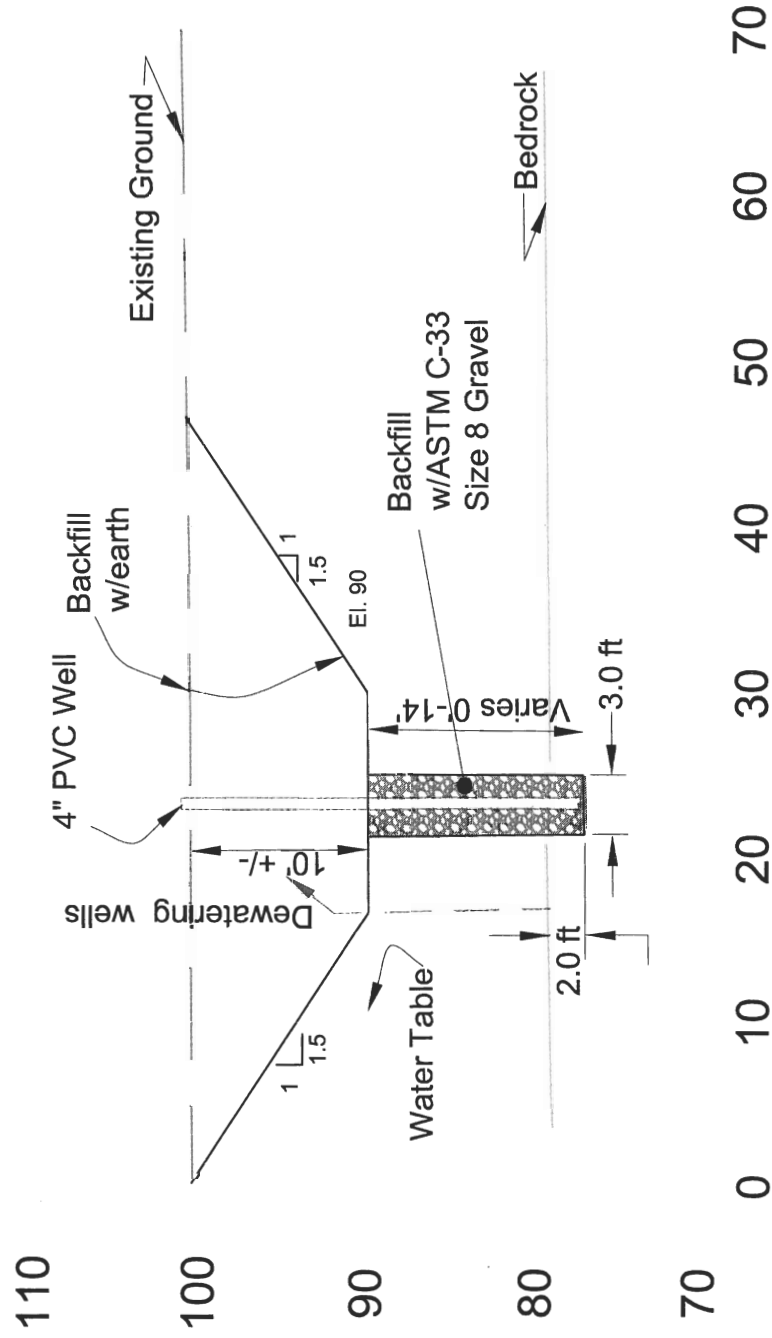
Figure 5

Cross Section B-B'

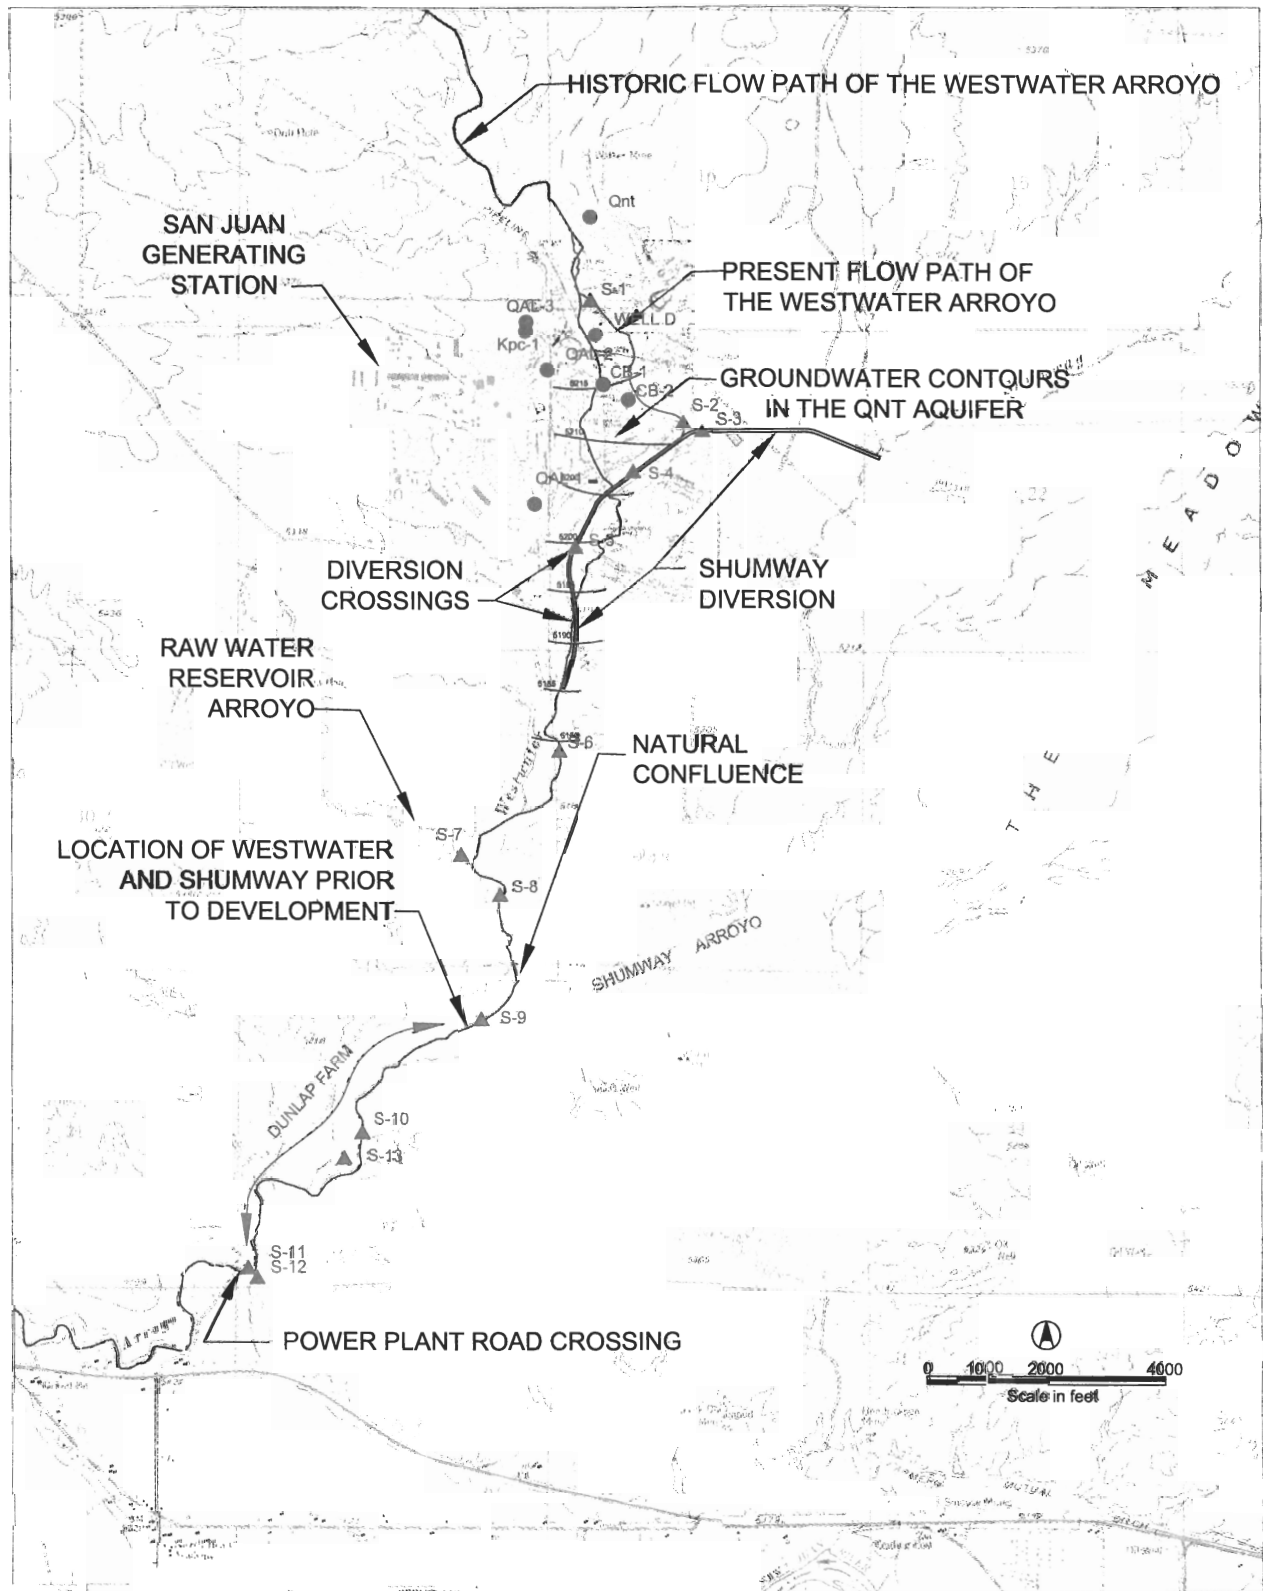
**FIGURE 1**  
**MONITORING STATION LOCATION MAP**  
**WESTWATER AND SHUMWAY ARROYO**  
**HYDRAULIC INVESTIGATION**

Flow measurements were made at 13 stations (S-1 to S-13 on FIGURE 1) along an approximate four-mile long reach of the Westwater and Shumway Arroyos. The flow measurements were made using a standard USGS mini-current meter and a standard wading rod. The velocity area method was used. Velocity measurements were taken at 0.6 of the total depth below the water surface as described in USGS, 1977. The 13 flow measurement stations shown on FIGURE 1 are described as follows:

- Station S-4 is located at the upstream edge of a seep occasionally observed in the Shumway Diversion.
- Station S-5 is located just upstream from the La Plata haul road crossing in the Shumway Diversion.

- Station S-6 is located in the Westwater Arroyo at the San Juan Mine irrigation water pipeline crossing.
- Station S-7 is located in the Raw Water Reservoir Arroyo just upstream from its confluence with the Westwater Arroyo.

- Station S-8 is located in the Westwater Arroyo just downstream from the red gravel road crossing.
- Station S-9 is located in the Shumway Arroyo at the upstream edge of the Dunlap Farm.
- Station S-10 is located in the Shumway near the middle of the Dunlap Farm.
- Station S-11 is located in the Shumway Arroyo at the downstream edge of the Dunlap Farm and just upstream from Power Plant Road Crossing.
- Station S-12 is located in the Farmers Mutual Ditch Wastewater. This flow is included in the measurements made at S-11.
- Station S-13 is located in the Wasteway from the Dunlap Farm irrigation storage reservoir. This flow is included in the measurements made at S-11.

METRIC Corporation's investigations of the Westwater and Shumway drainages conducted between 1981 and 1984 established the presence of a naturally occurring linear aquifer within the unconsolidated sediments, (Qnt and Qal) of those two drainages. That aquifer passes along the east side of the San Juan Generating Station, (see FIGURE 1).

The Qnt aquifer is a linear saturated unconsolidated deposit, which generally follows the historic flow path of the Westwater Arroyo and then the flow path of the Shumway Arroyo downstream from the natural confluence (FIGURE 1). The aquifer is about 1000 feet wide and 20 feet thick in the vicinity of the San Juan Generating Station.

The sources of the arroyo water sampled at station S-8 are difficult to explain due to a general lack of groundwater data in the area. The arroyo water sampled at station S-11 almost certainly consists of Qnt groundwater with direct contributions of Farmers Mutual Ditch irrigation water and irrigation water, which percolates downward from the irrigated fields of the Dunlap Farm (FIGURE 1) and enters the Qnt aquifer.
